### Presentation of balustrade and chimney model

# CONSERVATION OF GEORGIAN BALUSTRADES

Dimitris Theodossopoulos, Daphne Kessissoglou, Scottish Centre for Conservation Studies, University of Edinburgh

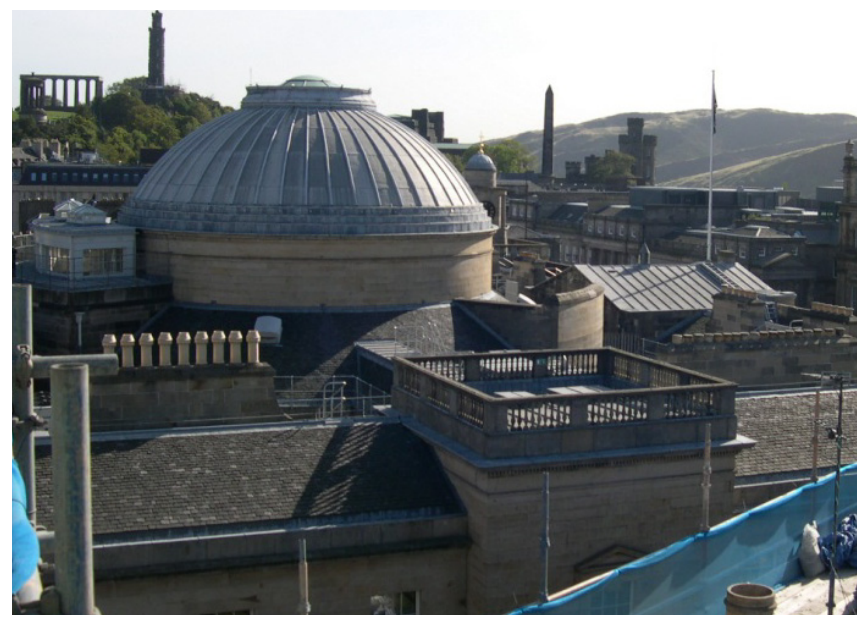
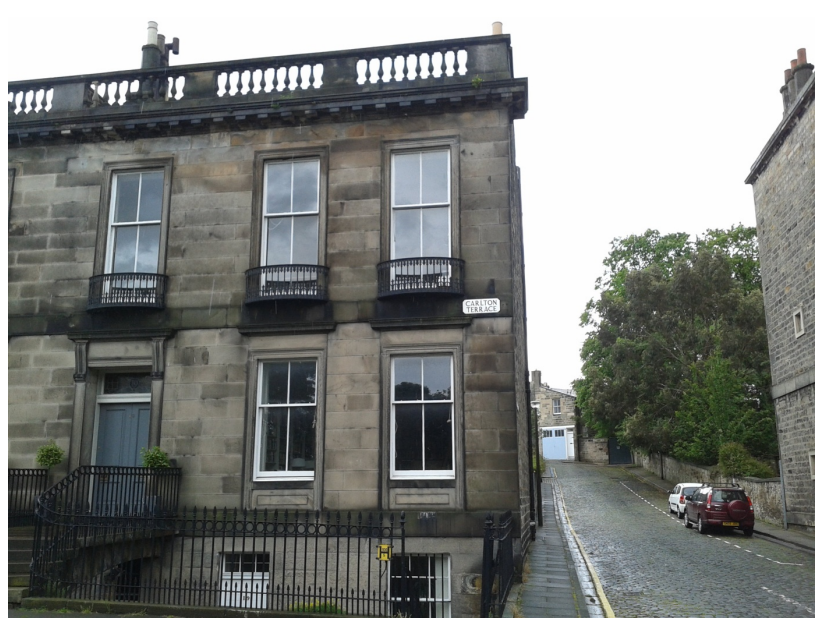
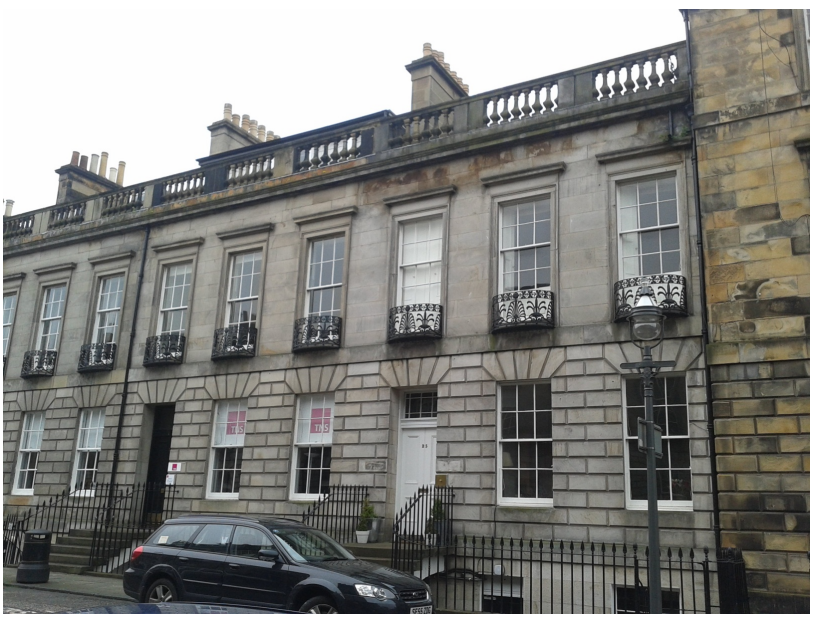
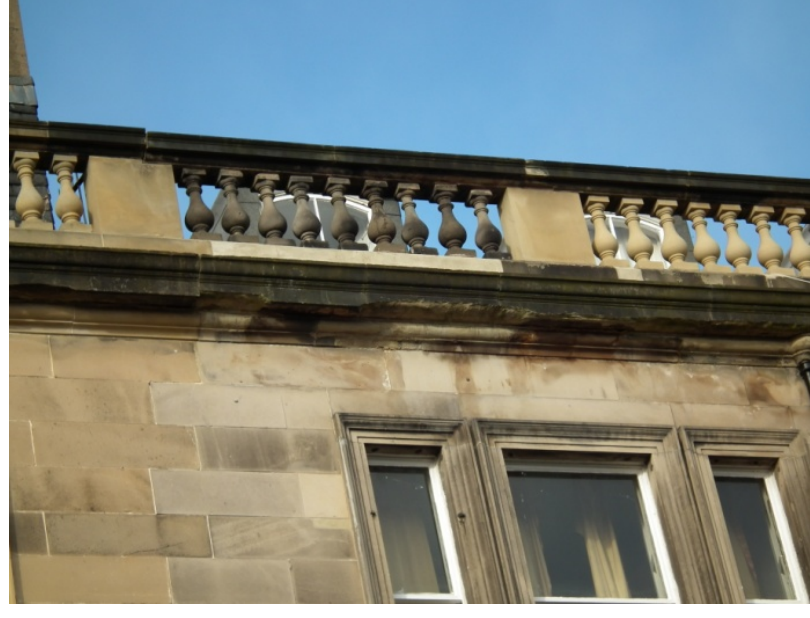
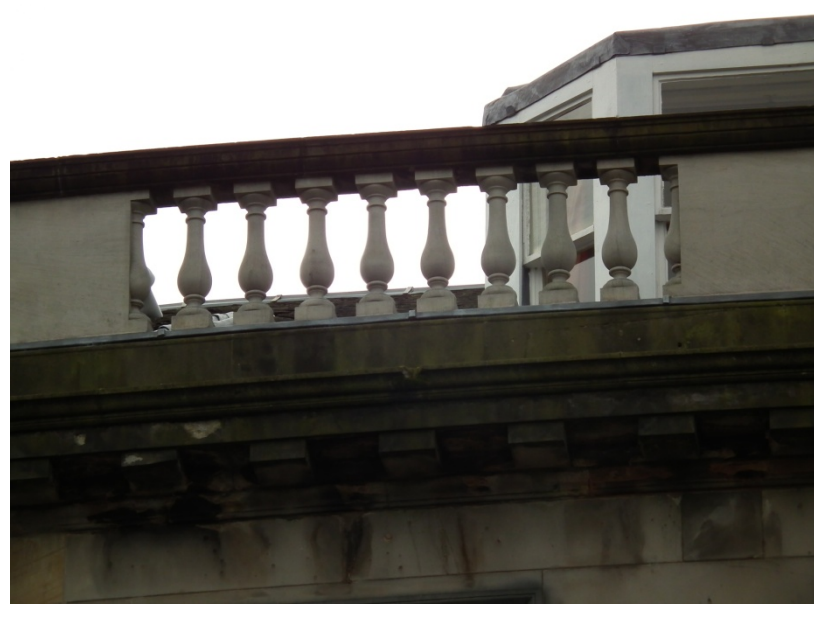
Coronation of the wallheads in many terraced houses, “sealing” visually the edge of a roof with an elegant end to the flashing of the coverings and the gutter. Often the signature of an architect, they are characterised by how densely they are arranged between the piers. Victorian cornices are stronger and bolder than earlier Georgian.

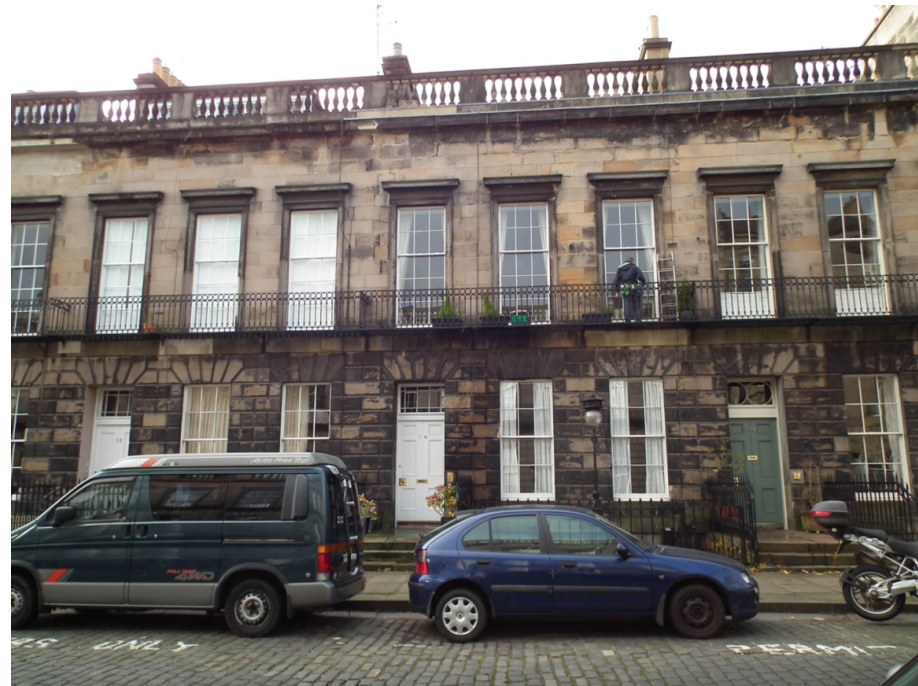
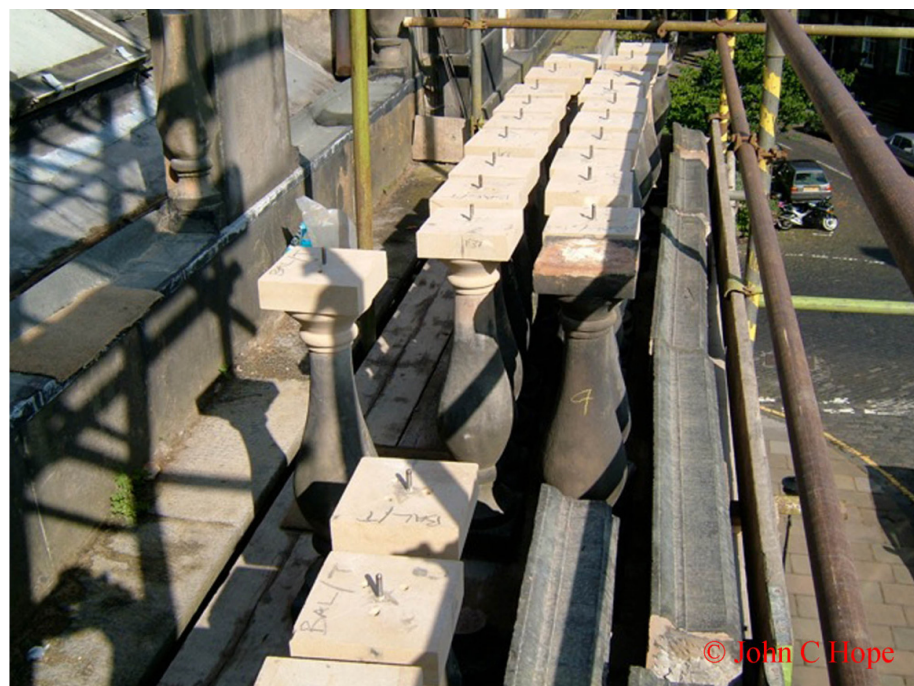
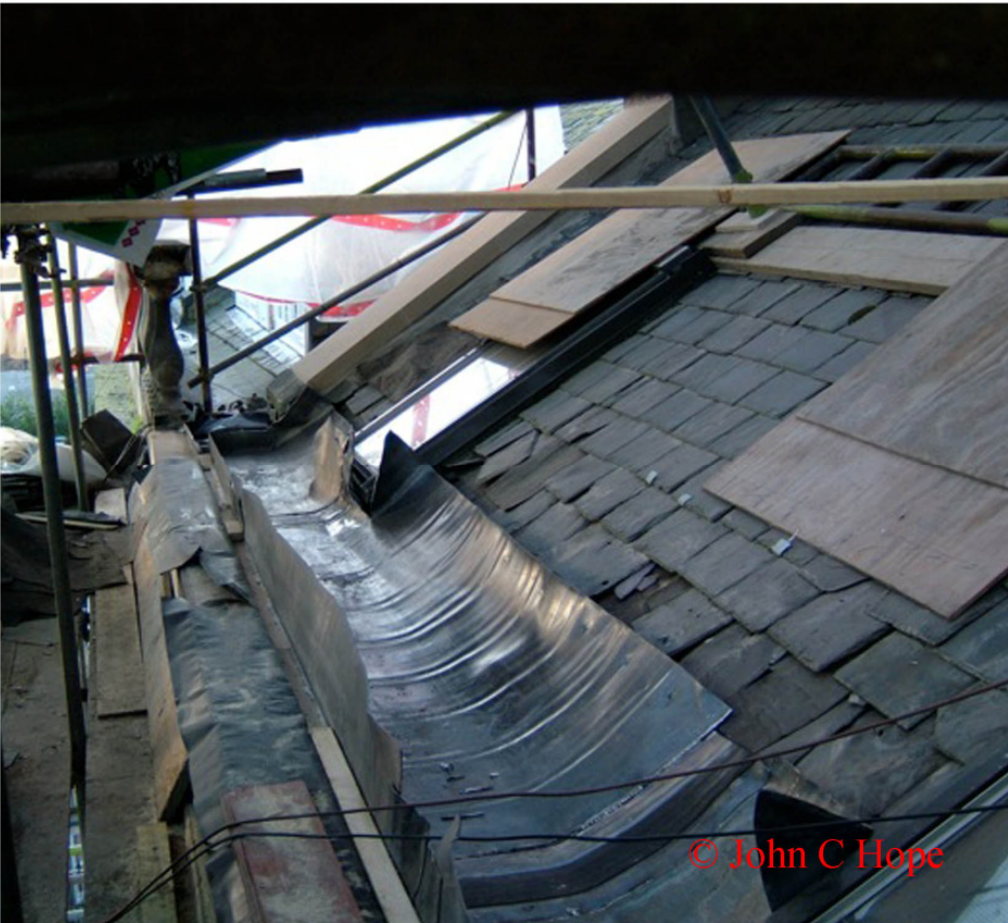
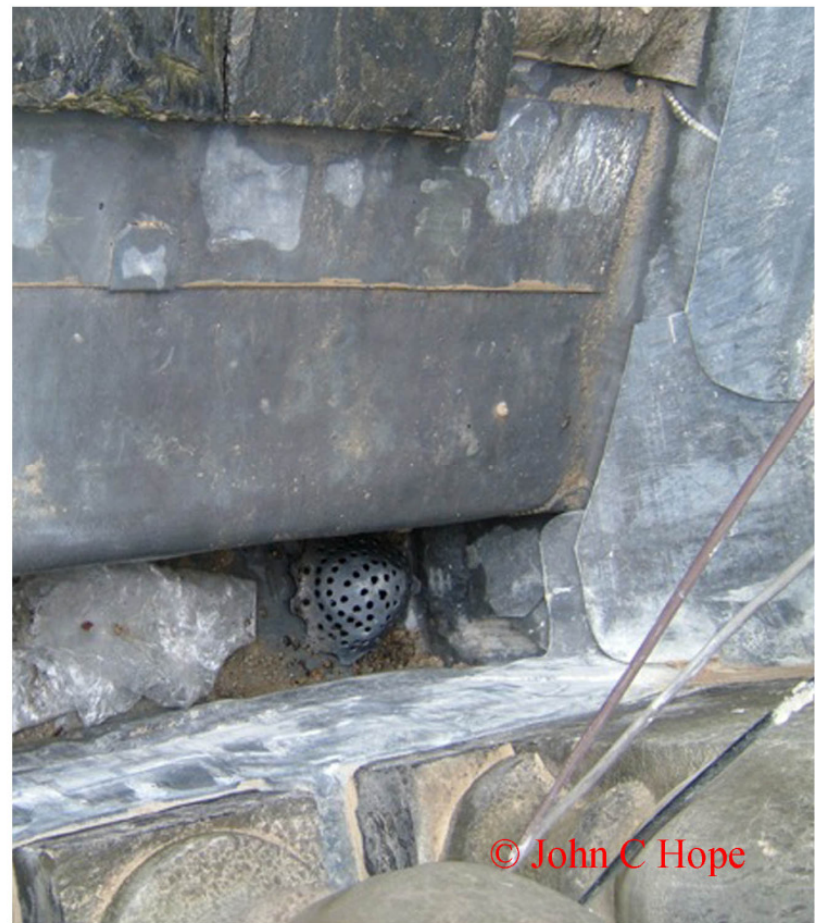
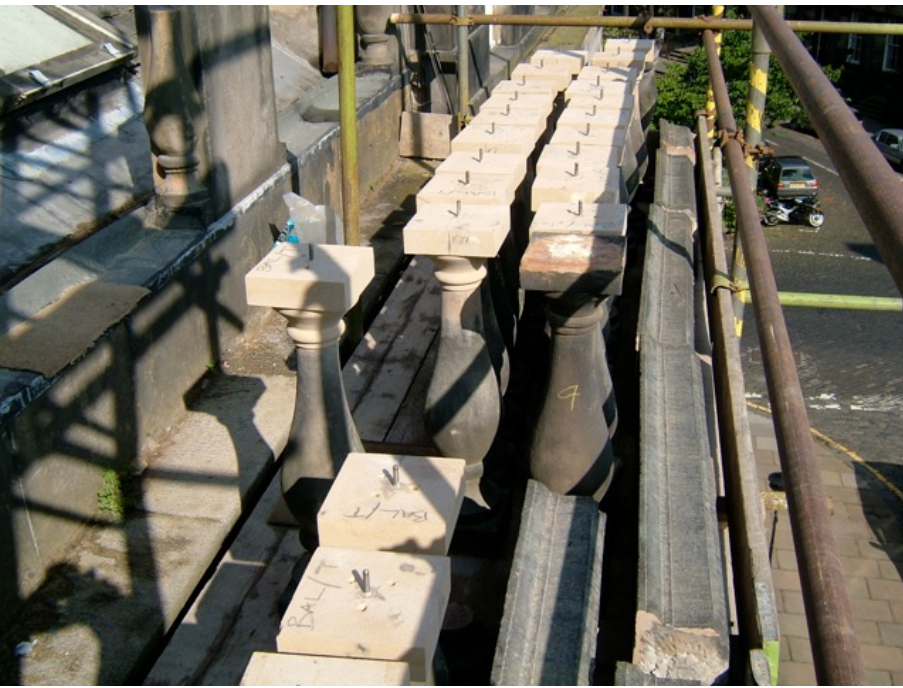
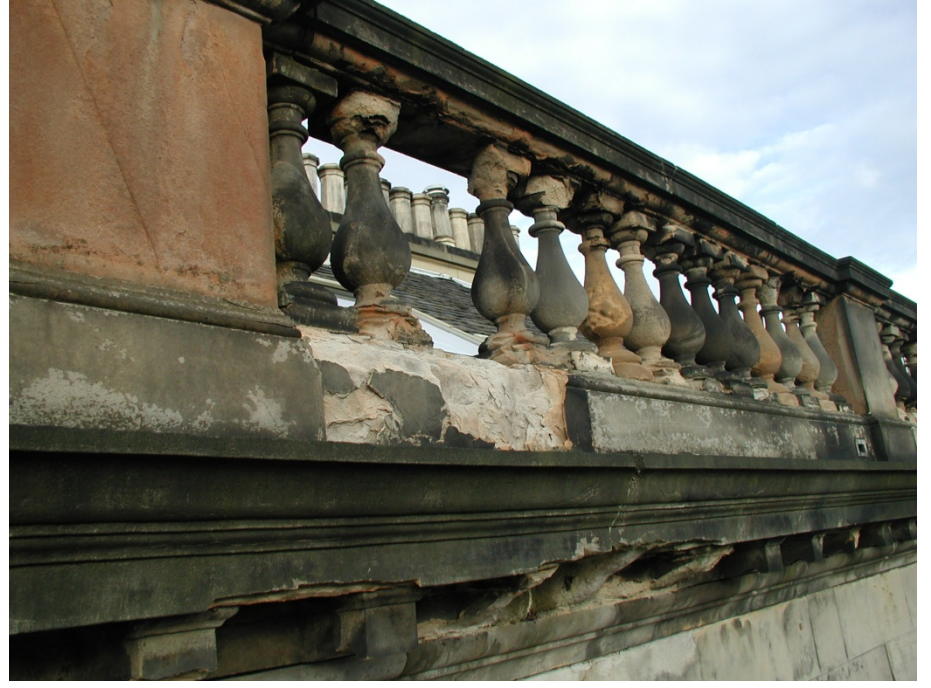
14-16 Carlton Street (James Milne 1826), repairs by John Hope, 2012

New pieces fixed with drop dowels to the coping, and with dowels to the original part. New ones will be turned from a template of the original ones. Variation of joints: lead joggle or U-shaped iron clamp
